Application of Strut-and-Tie Model in Structural Concrete Repair

John F. Duntemann, P.E., S.E.

Wiss, Janney, Elstner Associates, Inc.
Northbrook, IL, USA

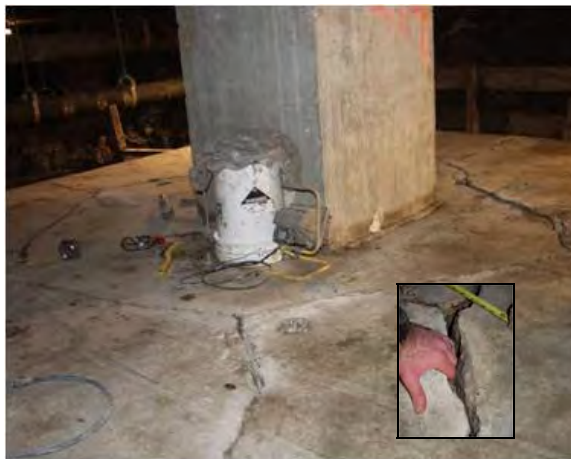
Structural repairs were performed at a hospital to address severe and widespread structural cracking in the pile cap foundations. The foundations are massive concrete blocks, typically 15 ft by 15 ft in plan and 7 ft deep. The pile caps are reinforced with a single orthogonal mat of steel at the bottom of the cap and had a specified concrete compressive strength of 6,000 psi. Wide cracks had developed in the top and side surfaces of several pile caps as shown in Figures 1 and 2.

Figure 1. Typical cracking on top of pile cap.

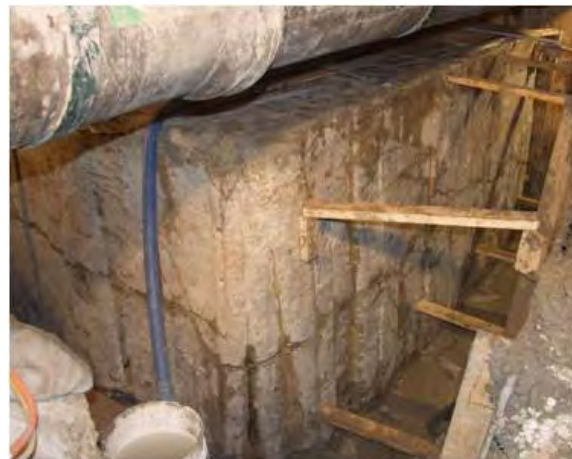
Figure 2. Cracking on side surfaces.
