# Collapse and Repair of a Beam Support of the General Rafael Urdaneta Bridge, Crossing the Maracaibo Lake in Venezuela

**Luis B. FARGIER G.**

## Summary

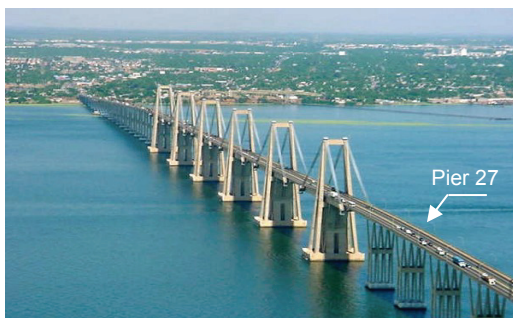
*Fig. 1: Aerial view. Bridge General Rafael Urdaneta (www.correodelorinoco.gob.ve)*

An aerial picture of the GRU Bridge is shown in Figure 1.

The failure of the roller occurred at Pier 27, which is shown in Figure 1. A Sketch of the span resting on Pier 27 is shown in Figure 2, including a plot of the typical supports used in the bridge and a picture taken from the original structural drawings. Typical deck cross-section is shown in Figure 3. Prestressed girders, spaced at 4.5 m are the main components of the deck.
